**Flood Control Project Maintenance  
Levee Inspections**

**Maintenance Issue Types Only, Levee Inspection Report By Mile - Fall 2016**

**Sutter Maintenance Yard Maintenance Area 0007**

Waterway	Bank	Unit Miles	Inspection Start/End	Inspector
Unit No. 01 Feather River	Right	11.90	09/07/2016 09/08/2016	Sterling York

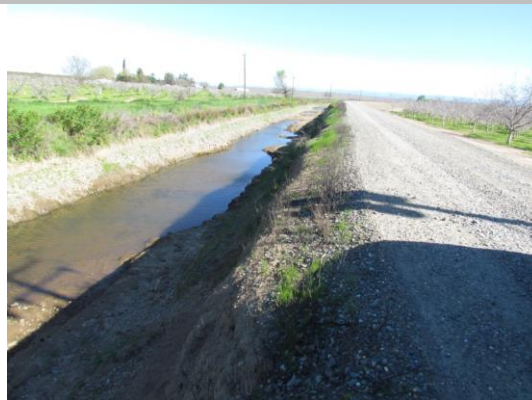
Photo 1 of 2 : FA\_2016\_MA0007\_200\_42\_20160906\_00006.jpg

LM Start	0.03	Rating **	M	Issue No.	42
LM End	1.72	Issue Type +	Ma	Location *	LS
Category	Earthen Levee			GPS Latitude/Longitude	
				Start	End
Item	Erosion / Bank Caving			39.311297 °	39.334365 °
				-121.637490 °	-121.633975 °
DWR ID	DWR_MA0007_01_s_2012_42				
Comment Code					
E1 : Note and monitor erosion site.					
Inspector Comment					
Erosion along landward levee slope due to agricultural ditch.

This photo was taken from the levee crown facing north looking at the erosion along the landward levee slope due to an agricultural ditch. Spring 2014.

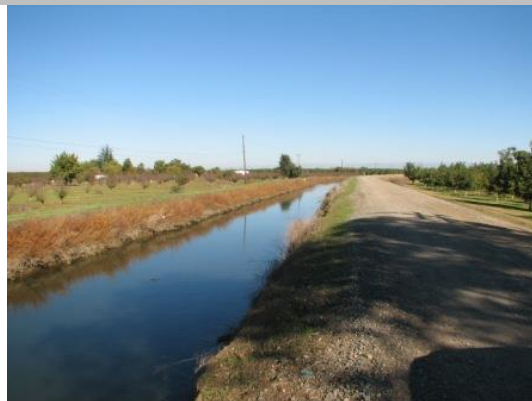
Photo 2 of 2 : FA\_2016\_MA0007\_200\_42\_20160906\_00007.jpg

LM Start	0.03	Rating **	M	Issue No.	42 (cont)
LM End	1.72	Issue Type +	Ma	Location *	LS
Category	Earthen Levee			GPS Latitude/Longitude	
				Start	End
Item	Erosion / Bank Caving			39.311297°	39.334365°
				-121.637490°	-121.633975°
DWR ID	DWR_MA0007_01_s_2012_42				
Comment Code					
E1 : Note and monitor erosion site.					
Inspector Comment					
Erosion along landward levee slope due to agricultural ditch.

Agricultural ditch landside slope and toe.

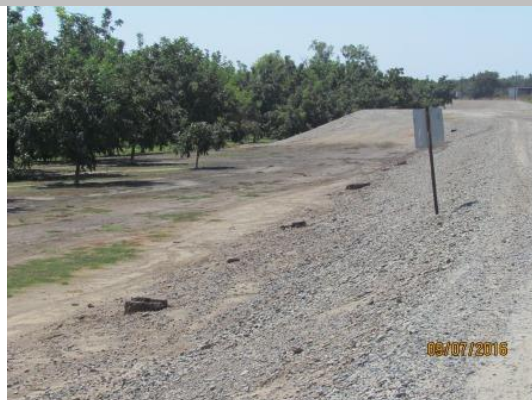
Photo 1 of 1 : FA\_2016\_MA0007\_200\_69\_20160912\_00125.jpg

LM Start	0.31	Rating **	N	Issue No.	69
LM End	0.37	Issue Type +	Ma	Location *	WS
Category	Earthen Levee			GPS Latitude/Longitude	
				Start	End
Item	Trim / Thin Trees			39.314991 °	39.315693 °
				-121.635038 °	-121.634459 °
DWR ID	DWR_MA0007_01_s_2016_69				
Comment Code					
T5 : Tree stumps.					
Inspector Comment					
Several tree stumps at levee toe.

View looking downstream of several tree stumps at the levee toe on the waterside.

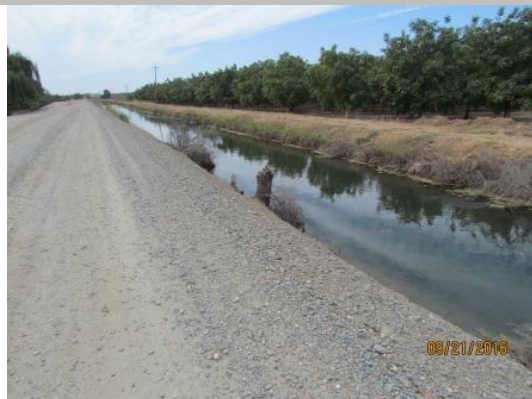
Photo 1 of 1 : FA\_2016\_MA0007\_200\_72\_20160923\_00126.jpg

LM Start	0.44	Rating **	U	Issue No.	72
LM End	0.44	Issue Type +	Ma	Location *	LS
Category	Earthen Levee			GPS Latitude/Longitude	
				Start	End
Item	Trim / Thin Trees			39.316527 °	39.316527 °
				-121.633800 °	-121.633800 °
DWR ID	DWR_MA0007_01_f_2016_72				
Comment Code					
T5 : Tree stumps.					
Inspector Comment					
This stump is next to the canal on the landside and is decomposing and needs to be removed.

View of a stump on the landside slope looking downstream. This stump is next to the canal on the landside and is decomposing and needs to be removed.

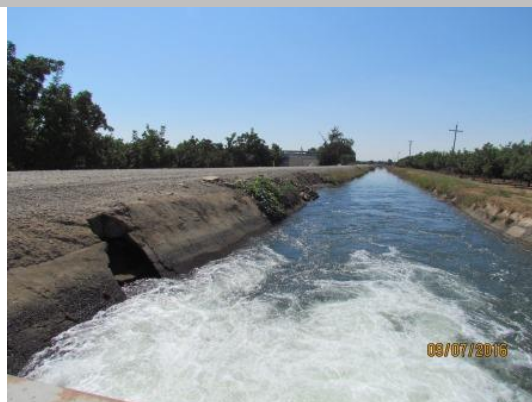
Photo 1 of 1 : FA\_2016\_MA0007\_200\_68\_20160912\_00124.jpg

LM Start	0.56	Rating **	M	Issue No.	68
LM End	0.56	Issue Type +	Ma	Location *	LS
Category	Earthen Levee			GPS Latitude/Longitude	
				Start	End
Item	Erosion / Bank Caving			39.317974 °	39.317974 °
				-121.632542 °	-121.632542 °
DWR ID	DWR_MA0007_01_s_2016_68				
Comment Code					
E1 : Note and monitor erosion site.					
Inspector Comment					
Eroding slope due to irrigation ditch on landside slope, looking downstream.

View of eroding slope due to irrigation ditch on landside slope, looking downstream.

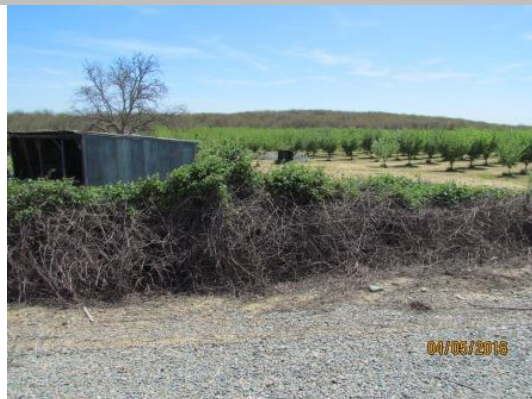
Photo 1 of 1 : FA\_2016\_MA0007\_200\_67\_20160906\_00020.jpg

LM Start	0.92	Rating **	A/W	Issue No.	67
LM End	0.92	Issue Type +	Ma	Location *	LS
Category	Earthen Levee			GPS Latitude/Longitude	
				Start	End
Item	Vegetation			39.323118°	39.323118°
				-121.632205°	-121.632205°
DWR ID	DWR_MA0007_01_s_2016_67				
Comment Code					
V2 : Remove the wild growth other than native grasses from the levee slopes.					
Inspector Comment

View of landside toe vegetation looking downstream.

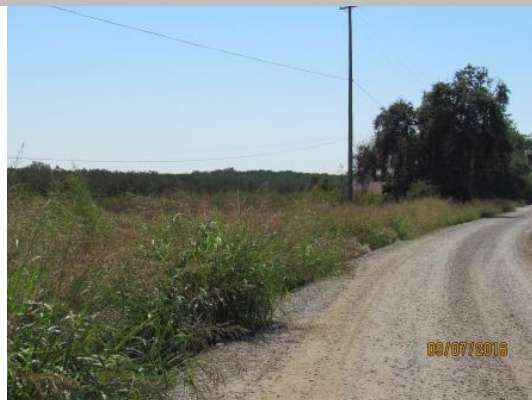
Photo 1 of 1 : FA\_2016\_MA0007\_200\_71\_20160912\_00123.jpg

LM Start	1.00	Rating **	M	Issue No.	71
LM End	1.12	Issue Type +	Ma	Location *	WS
Category	Earthen Levee			GPS Latitude/Longitude	
				Start	End
Item	Vegetation			39.324172 °	39.325938 °
				-121.631792 °	-121.631853 °
DWR ID	DWR_MA0007_01_f_2016_71				
Comment Code					
V1 : Control annual grass and weeds on the levee slopes and easements.					
Inspector Comment					
Waterside annual grasses that need to be maintained.

View of waterside annual grasses that need to be maintained. Looking downstream.

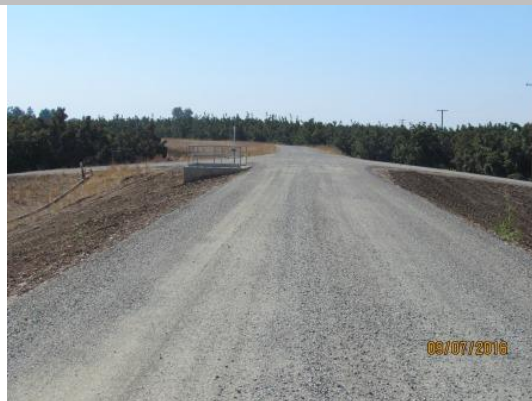
Photo 1 of 1 : FA\_2016\_MA0007\_200\_38\_20160912\_00122.jpg

LM Start	1.14	Rating **	A	Issue No.	38
LM End	10.68	Issue Type +	Ma	Location *	LS
Category	Earthen Levee			GPS Latitude/Longitude	
				Start	End
Item	Vegetation			39.326177°	39.426842°
				-121.631967°	-121.642087°
DWR ID	DWR_MA0007_01_f_2016_38				
Comment Code					
V1 : Control annual grass and weeds on the levee slopes and easements.					
Inspector Comment					
Maintained annual grasses.

View looking downstream of maintained annual grasses.

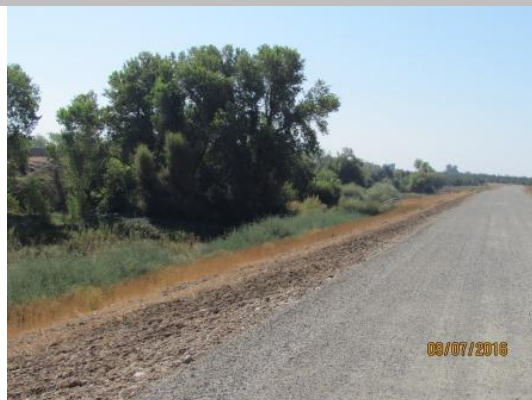
Photo 1 of 1 : FA\_2016\_MA0007\_200\_37\_20160912\_00121.jpg

LM Start	1.14	Rating **	A	Issue No.	37
LM End	10.68	Issue Type +	Ma	Location *	WS
Category	Earthen Levee			GPS Latitude/Longitude	
				Start	End
Item	Vegetation			39.326177 °	39.426843 °
				-121.631968 °	-121.642087 °
DWR ID	DWR_MA0007_01_f_2016_37				
Comment Code					
V1 : Control annual grass and weeds on the levee slopes and easements.					
Inspector Comment					
Maintained annual grasses.

View looking downstream of maintained annual grasses.

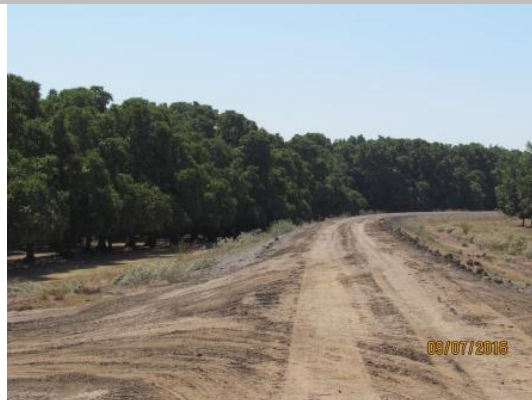
Photo 1 of 1 : FA\_2016\_MA0007\_200\_62\_20160912\_00120.jpg

LM Start	1.82	Rating **	A/W	Issue No.	62
LM End	2.53	Issue Type +	Ma	Location *	CR
Category	Earthen Levee			GPS Latitude/Longitude	
				Start	End
Item	Crown Surface / Depressions / Rutting			39.335774 °	39.345322 °
				-121.633888 °	-121.629603 °
DWR ID	DWR_MA0007_01_f_2016_62				
Comment Code					
C1 : Add appropriate material and re-grade the levee to bring the crown above the design elevation.					
Inspector Comment					
This section of levee has been brought back to design elevation but still needs the aggregate base placed.

View of levee that has been brought back to design elevation but still needs the aggregate base placed. Looking downstream.

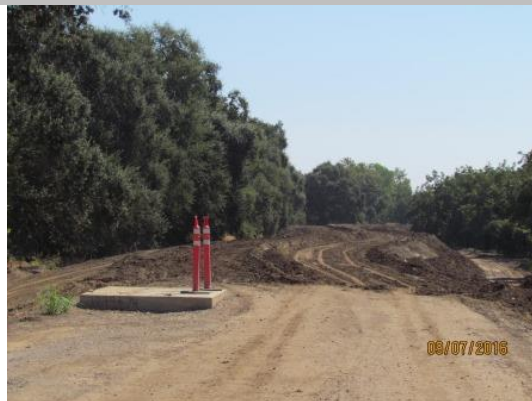
Photo 1 of 1 : FA\_2016\_MA0007\_200\_61\_20160912\_00119.jpg

LM Start	2.53	Rating **	A/W	Issue No.	61
LM End	3.33	Issue Type +	Ma	Location *	CR
Category	Earthen Levee			GPS Latitude/Longitude	
				Start	End
Item	Crown Surface / Depressions / Rutting			39.345322°	39.354627°
				-121.629604°	-121.635530°
DWR ID	DWR_MA0007_01_f_2016_61				
Comment Code					
C2 : Repair depressions or ruts in the crown or slope.					
Inspector Comment					
This section of levee is currently under construction and has been degraded and is being brought back to design elevation.

View of the levee that is currently under construction and has been degraded and is being brought back to design elevation, looking downstream.

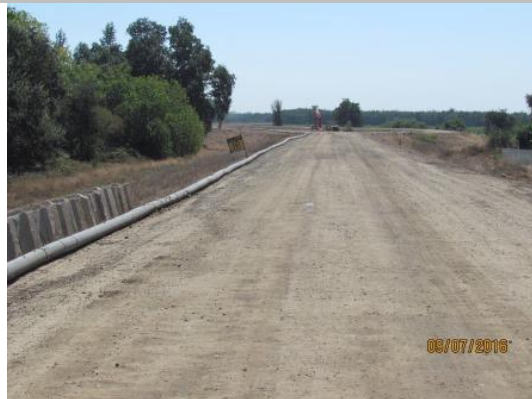
Photo 1 of 1 : FA\_2016\_MA0007\_200\_60\_20160912\_00118.jpg

LM Start	3.32	Rating **	A/W	Issue No.	60
LM End	4.29	Issue Type +	Ma	Location *	CR
Category	Earthen Levee			GPS Latitude/Longitude	
				Start	End
Item	Crown Surface / Depressions / Rutting			39.354596 °	39.365418 °
				-121.635404 °	-121.646539 °
DWR ID	DWR_MA0007_01_f _ 2016_60				
Comment Code					
C1 : Add appropriate material and re-grade the levee to bring the crown above the design elevation.					
Inspector Comment					
This section of levee has been brought back to design elevation but still needs the aggregate base placed.

View of levee that has been brought back to design elevation but still needs the aggregate base placed. Looking down stream.

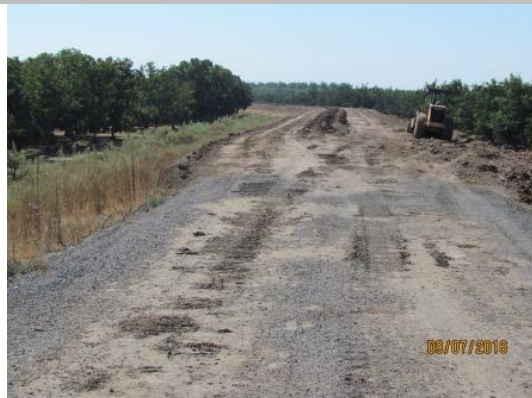
Photo 1 of 1 : FA\_2016\_MA0007\_200\_54\_20160912\_00114.jpg

LM Start	7.00	Rating **	A/W	Issue No.	54
LM End	7.90	Issue Type +	Ma	Location *	CR
Category	Earthen Levee			GPS Latitude/Longitude	
				Start	End
Item	Crown Surface / Depressions / Rutting			39.392205 °	39.401297 °
				-121.627899 °	-121.630883 °
DWR ID	DWR_MA0007_01_f_2016_54				
Comment Code					
C2 : Repair depressions or ruts in the crown or slope.					
Inspector Comment					
This portion of the levee is currently under construction and has been degraded and is being brought back to design elevation.

View of this portion of the levee that is currently under construction that has been degraded and is being brought back to design elevation.

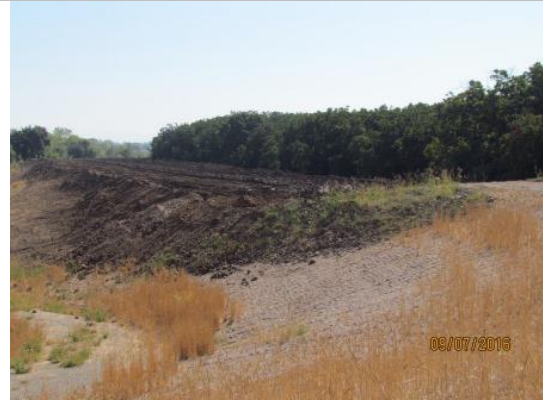
Photo 1 of 1 : FA\_2016\_MA0007\_200\_47\_20160912\_00113.jpg

LM Start	9.06	Rating **	A/W	Issue No.	47
LM End	10.53	Issue Type +	Ma	Location *	CR
Category	Earthen Levee			GPS Latitude/Longitude	
				Start	End
Item	Crown Surface / Depressions / Rutting			39.411263 °	39.426682 °
				-121.634730 °	-121.639426 °
DWR ID	DWR_MA0007_01_s_2016_47				
Comment Code					
C3 : Add appropriate gravel or road base. Grade and compact.					
Inspector Comment					
This portion of the levee is currently under construction and has been degraded and is being brought back to design elevation.

View of the portion of levee that is currently under construction that has been degraded and is being brought back to design elevation.
